# Klamath National Forest

## Best Management Practices

MONITORING REPORT

2011 Fiscal Year

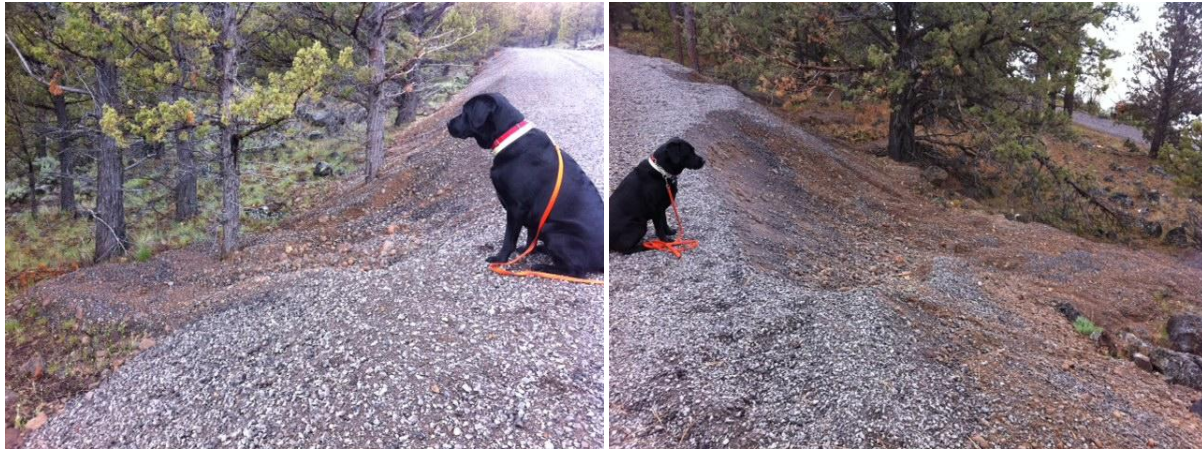
Orr Lake Rec. Dev. Project rd. 44N30X, Goosenest Ranger District- Not Implemented/At risk: The existing road was relocated from the lower slope to the upper slope, out of the riparian area to minimize impact to water quality in the lake. The fill slope lacking vegetation cover was required to be hydro seeded but

there is no evidence that it was done. There were minor rills on the fillslope and several slope failures > 5 cubic yards but they did not reach the lake.

Figures 1a and 1b. Poor slope stabilization in Orr Lake Rec. Dev. Project

One out of four projects had implementation problems that caused BMP failures for both road surface and slope protection and stream crossing. The fill slope for the Orr Lake Recreation Development Project was required to be hydro seeded but there was no evidence that it was done. There were minor rills on the fillslope and several slope failures of > 5 cubic yards but they did not extend beyond the toe slope and did not reach the lake. The failure to apply hydro mulch could be corrected with better oversight to ensure that contract work is carried out as specified in engineering plans.

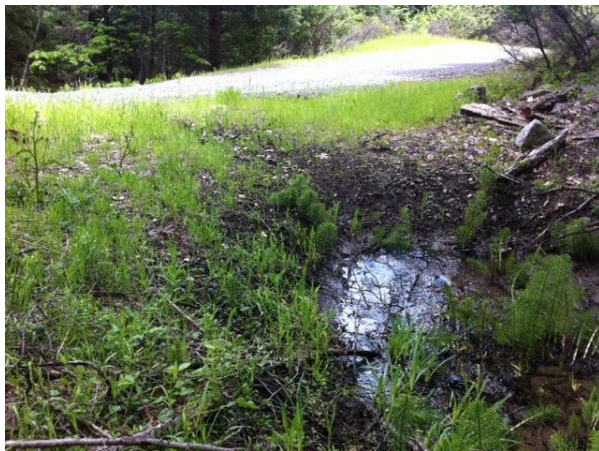
Little North Fork ERFO rd. 40N51, Salmon River District- Implemented/Effective: The culvert in a perennial channel is plugged with sediment by 70% but still effective in diverting water.

Figure 2a. Little North Fork ERFO rd. 40N51 inlet 70% plugged

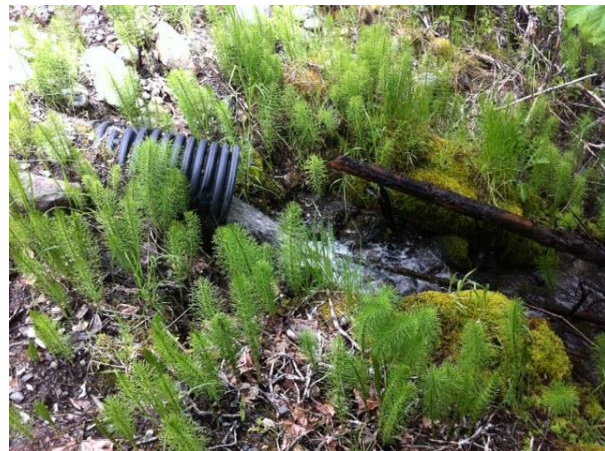
Figure 2b. Little North Fork ERFO rd. 40N51 culvert outlet

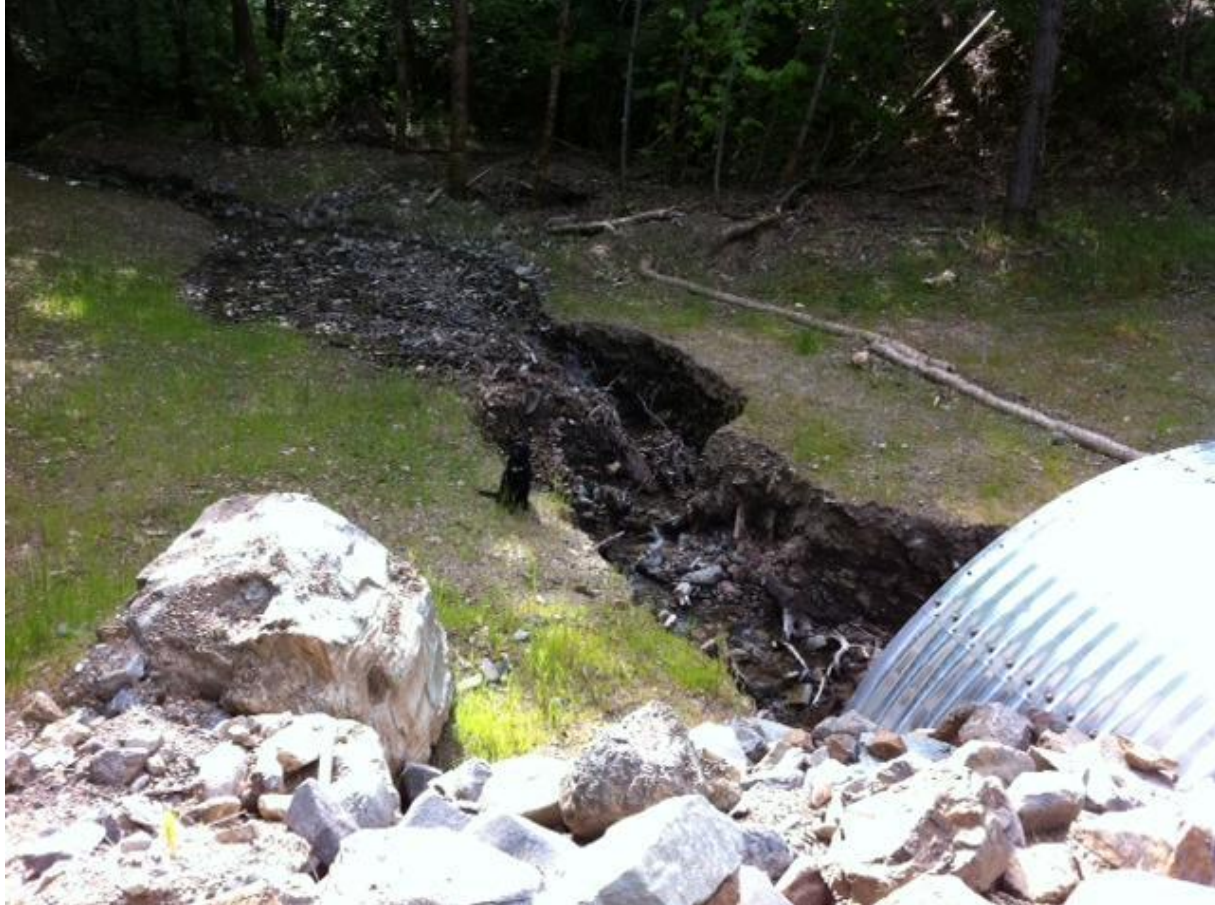
China-Fish Aquatic Passage ARRA rd. 47N77, Happy Camp District- Not Implemented/Not Effective: The old culvert restricted fish passage and it was replaced with a bottomless arch culvert designed to allow for natural stream bottom and to handle 100 year storm event. The purpose of the project was to minimize maintenance and sediment delivery. This project was completed in 2010 with the designed channel morphology being flat-bedded with small homogeneous gravel. The decision memo for Klamath Fish Passage Sites required that the fill material be excavated (approx. 550 ft<sup>3</sup>) to the depth of the original channel gradient and to the width of the canyon wall and/or floodplain at the base. Post-winter evaluation showed that the debris deposit was not excavated to the original channel depth, instead the

stream channel is incising with a 6 foot steep eroding bank. The downcut is 35ft upstream from the culvert inlet. Engineers plan to repair the site by farther excavating the debris deposit and push the width back against the canyon wall. This site requires a post-op evaluation in 2012 when the reconstruction is complete.

Figure 3. Down cut of fill material upstream of China-Fish Aquatic Passage culvert on rd. 47N77

The evaluation for China-Fish Aquatic Passage ARRA rd. 47N77 was rated as not implemented and not effective in 2011 due to problems in both the active and post-project phase of BMP evaluations. The problems during the active phase are described above. The problems in the post-project phase were due a failure to implementing the design plans that led to stream channel incision. The old culvert restricted fish passage and it was replaced with a bottomless arch culvert designed to allow for natural stream bottom and to handle 100 year storm event. The purpose of the project was to minimize maintenance and sediment delivery. This project was completed in 2010 with the designed channel morphology being flat-bedded with small homogeneous gravel. The decision memo for Klamath Fish Passage Sites required that the fill material be excavated (approx. 550 ft<sup>3</sup>) to the depth of the original channel gradient and to the width of the canyon wall and/or floodplain at the base. Post-winter evaluation showed that the debris deposit was not excavated to the original channel depth, instead the stream channel is incising with a 6 ft steep eroding bank. The downcut is 35 ft upstream from the culvert inlet. Engineers plan to repair the site by farther excavating the debris deposit and push the width back against the canyon wall. This site requires a post-op evaluation in 2012 when the reconstruction is complete.

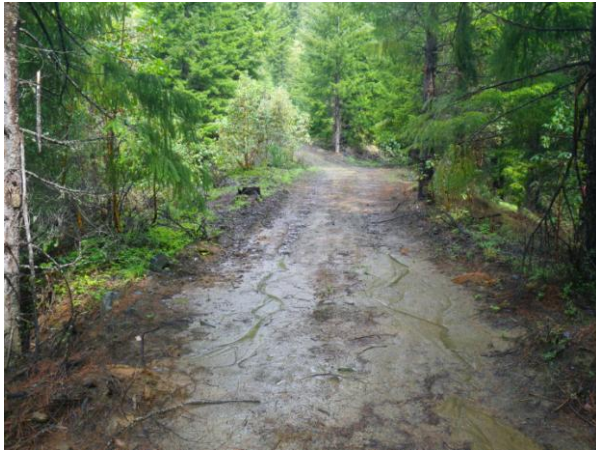
Tea Garden unit 27, Salmon River District- Not Implemented/Not Effective: The temporary road was graded and outsloped after logging operations and before the sale was closed but not blocked or waterbarred as specified in the environmental assessment (EA). The road was then re-opened by the District to allow woodcutter access to the slash pile at the landing. The granitic native surface road was used during wet weather causing rutting on the road, which concentrated flow down its length due to a lack of waterbars. The soil eroded from the road was deposited on the landing and no sediment reached the SMZ. District staff was alerted of the BMP failure and corrected the problem by blocking access to the temporary road with a large berm and installing waterbars.

Figure 4a. Tea Garden unit 27 temporary road before waterbar installation

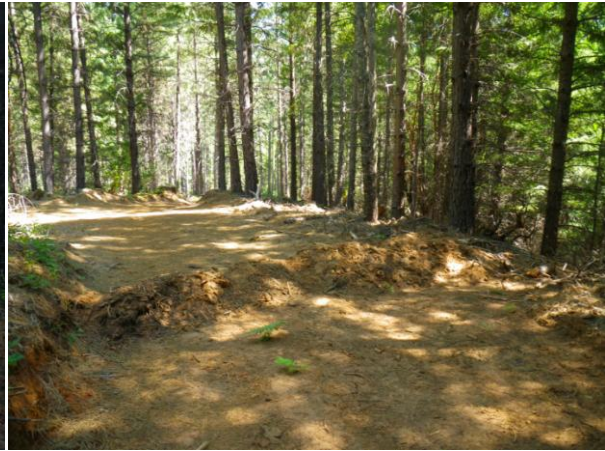
Figure 4b. Tea Garden unit 27 temporary road after waterbar installation

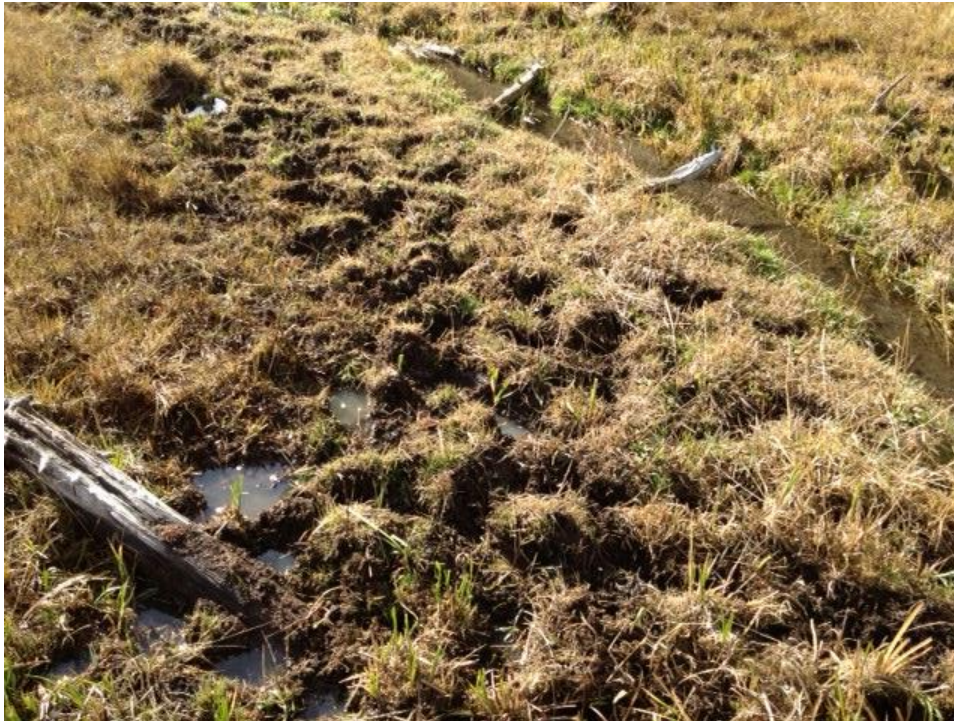
Horsethief, Goosenest District- Implemented/Effective: There was very little use of the streamside zone as evidenced by light herbaceous utilization. Trampling was evident due to saturated soils on less than 10% of the evaluated reach. Due to a high level of soil cover, the trampling did not deliver sediment into the channel. Bank stability was not impacted because trampling occurred a few feet away from the stream bank.

Figure 5. Tramping near stream in the Horsethief grazing allotment

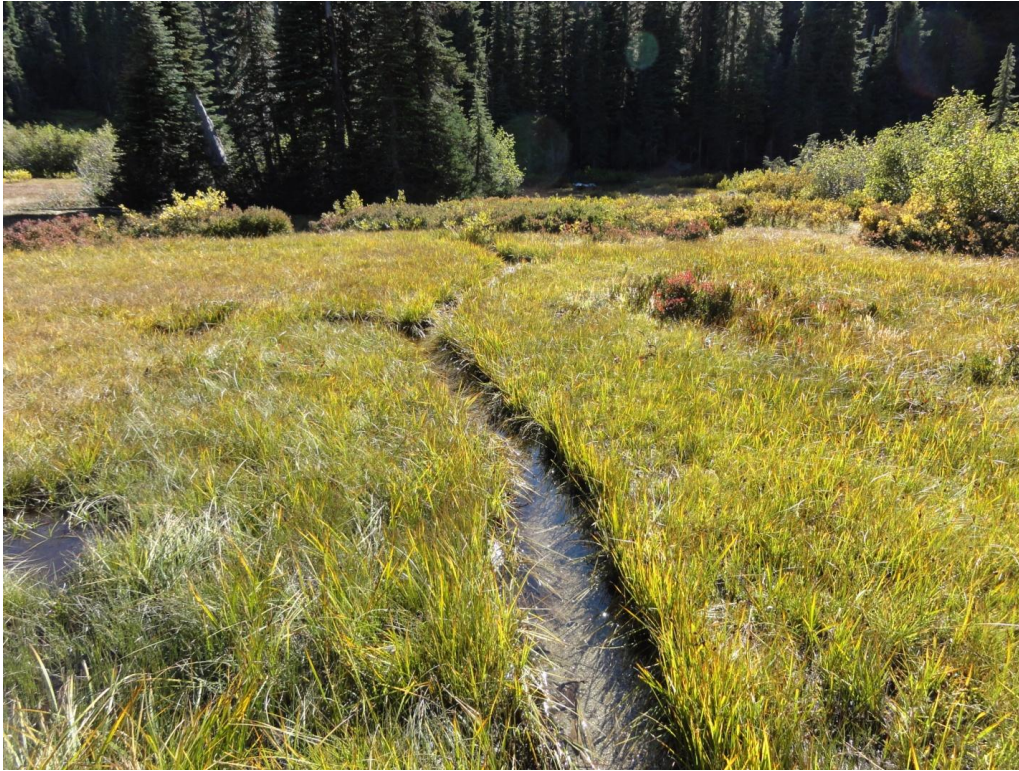
Shelly Meadows, Salmon River District- Implemented/Effective: The channel evaluated is deep, narrow, and dominated by *Carex* and *Juncas* species. Livestock alteration does not seem to be affecting streambank stability or stream shape as there are no observed cattle crossings due to the fact that cattle can easily step over the stream. Root masses are well established on the reach but streambanks are erodible due to the shallow granitic soils. Few woody species grow in the meadow. Shade is provided mainly from the herbaceous vegetation and overhanging stream banks. In addition, a few trees at the edge of the meadow are tall enough to shade the stream reach. Average shade along the stream was 19%. Implementation standards and guidelines were met and all effectiveness criteria were in the highest category.

Figure 6. Shelly Meadow allotment showing no signs of stream bank instability

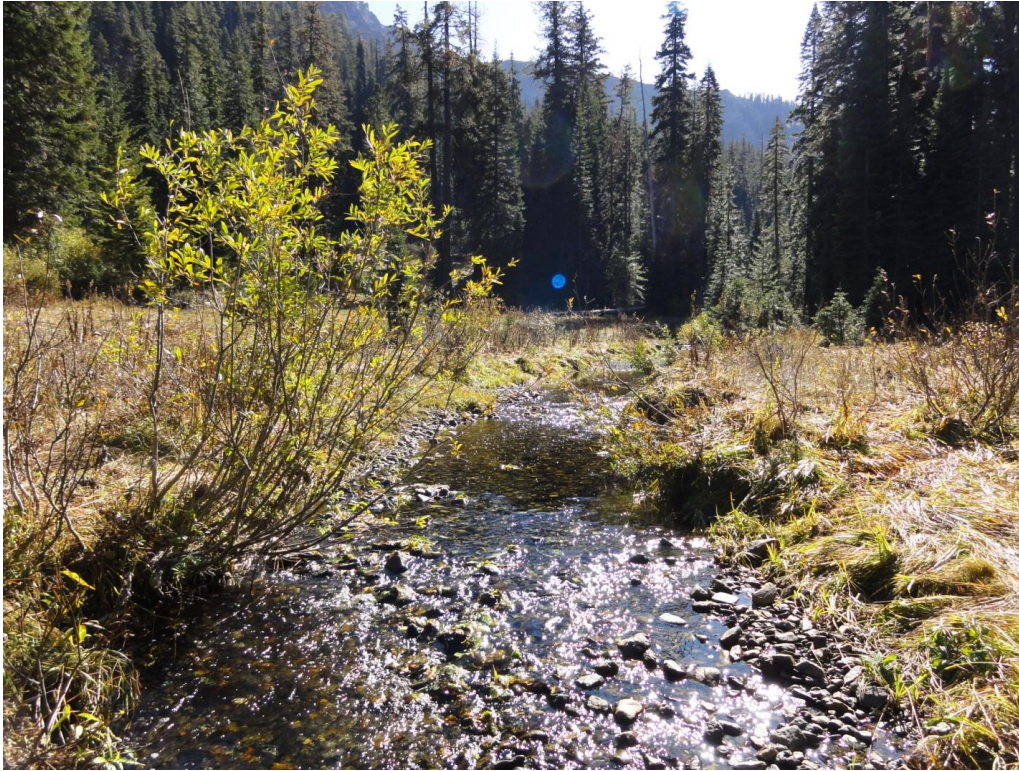
Figure 7. Red Rock allotment

Red Rock, Scott River District- Implemented/Effective: The monitoring site that was evaluated has a sloped moist meadow on one side of the creek and then a small wet meadow on the other side of the creek. The reach is lined with a diverse community of sedges, forbs, woody species and rocks, which provide stability to streambanks. The streambanks were covered with vegetation other than at three locations where cattle crossings occur. Some localized stream widening was observed due to trampling from both domestic and wild animals. No visible erosion is occurring on the meadow above the creek but there are many gopher mounds in the drier sections. Shade (average of 54%) is provided by tall conifers, willows, and alder shrubs. Implementation standards and guidelines were met and all effectiveness criteria were in the highest category.

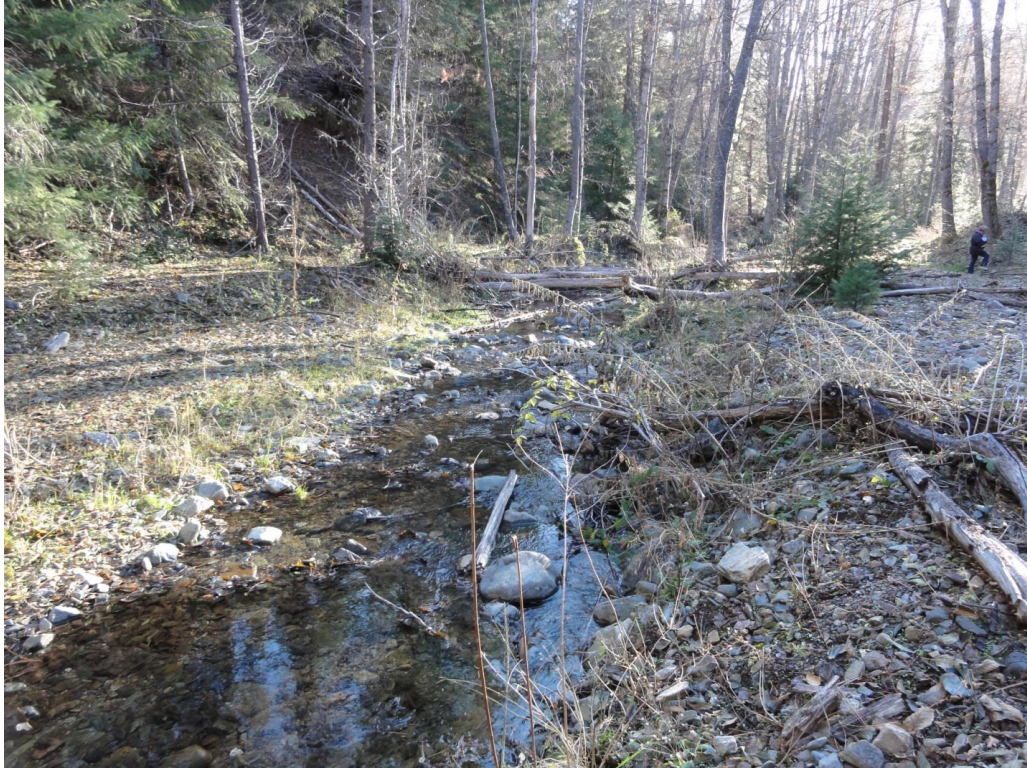
Figure 8. Indian creek allotment

Indian Creek, Scott River District- Implemented/Effective: The monitoring site that was evaluated met the highest standard for effectiveness in all categories except for riparian herbaceous vegetation. Along the stream bank 30-50% of herbaceous vegetation was composed of mid to late seral stage with root masses capable of withstanding annual runoff flows. This was a minor departure in standards and did not impact water quality.
